Device	XMC4700/XMC4800
Marking/Step	ES-AA, AA
Package	PG-LQFP-100/144, PG-LFBGA-196

Document ID is **03508AERRA**.

This “Errata Sheet” describes product deviations with respect to the user documentation listed below.

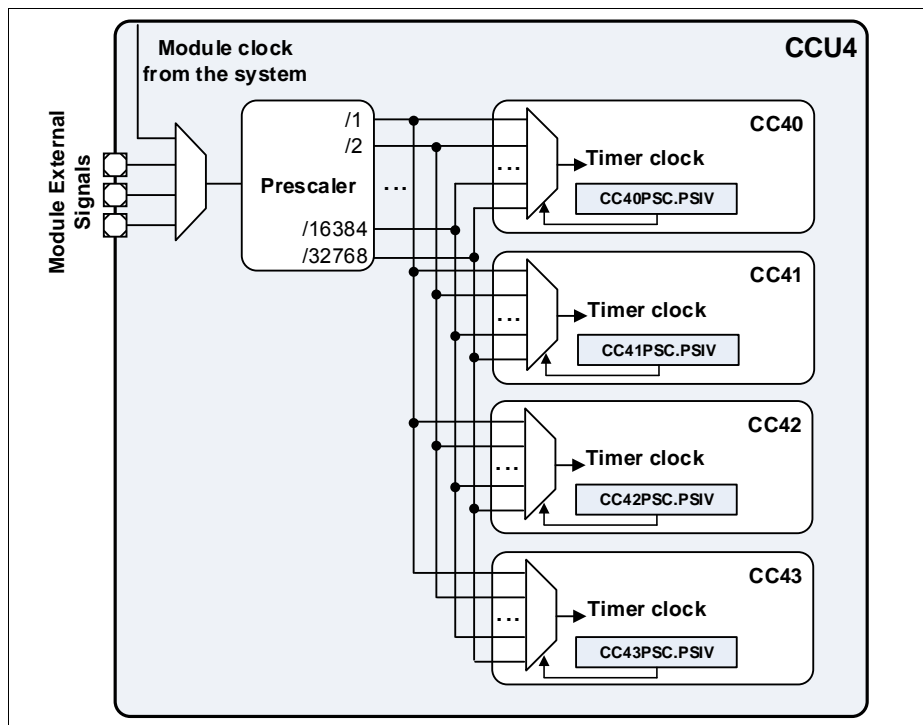
Figure 2 Clock Selection Diagram for CCU4

CCU_AI.005 CCU4 External IP clock Usage

Currently is only possible to use an external signal as Timer Clock when a division ratio of 2 or higher is selected. When no division is selected (divided by 1), the external signal cannot be used.

The user must program the PSIV field of each Timer Slice with a value different from 0000_B - minimum division value is /2.

None.

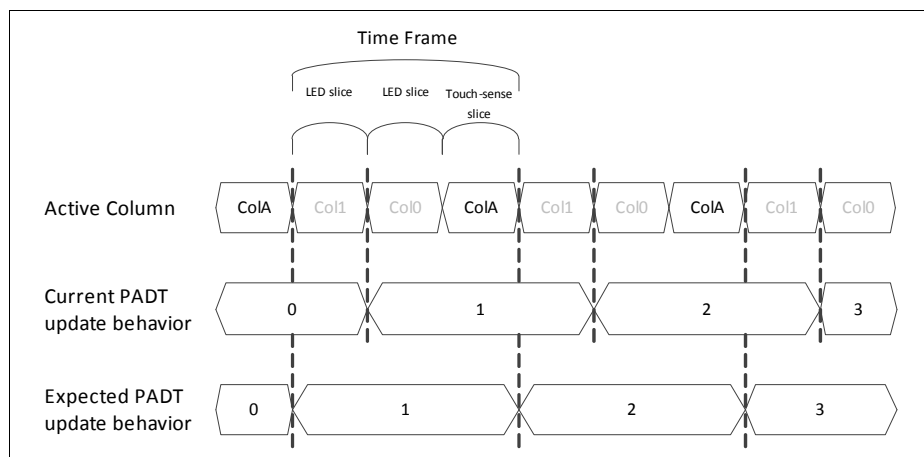
Figure 3 PADT update behavior

LEDTS AI.001 Delay in the update of FNCTL.PADT bit field

The touch-sense pad turn (PADT) value is updated, not at the end of the touch-sense time slice (ColA), but one time slice later ([Figure 3](#)).

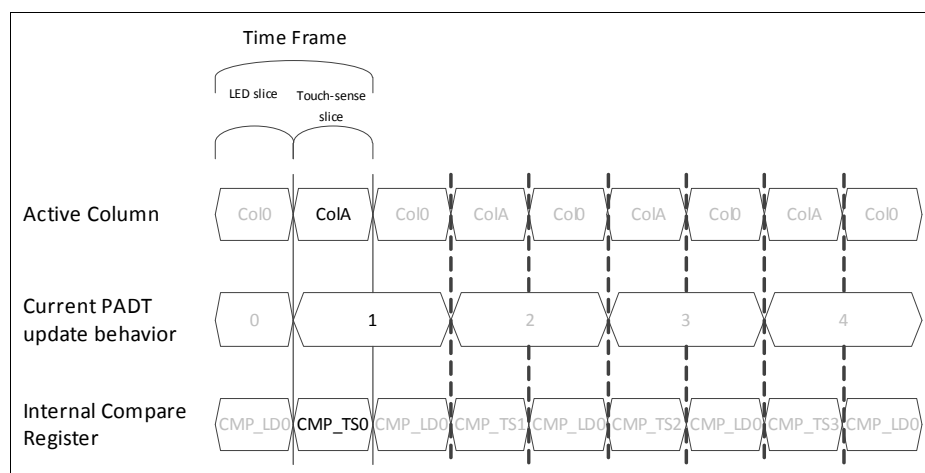
Figure 4 Effect of delay on the update of Internal Compare Register with 1 LED column enabled

If the number of LED columns enabled is smaller than 2, the delay will affect the activation period of the current active pad. At the beginning of every new Col A, the value of the current PADT's compare register is updated to the internal compare register. However, the delay causes the value of the previous PADT's compare register is updated to the internal compare register instead. This means that the current active pad would be activated with the duration of the previous pad's oscillation window (**Figure 4**). In addition to this, when no LEDs are enabled, pad turn 0 will prevail for one time slice longer before it gets updated (**Figure 5**).

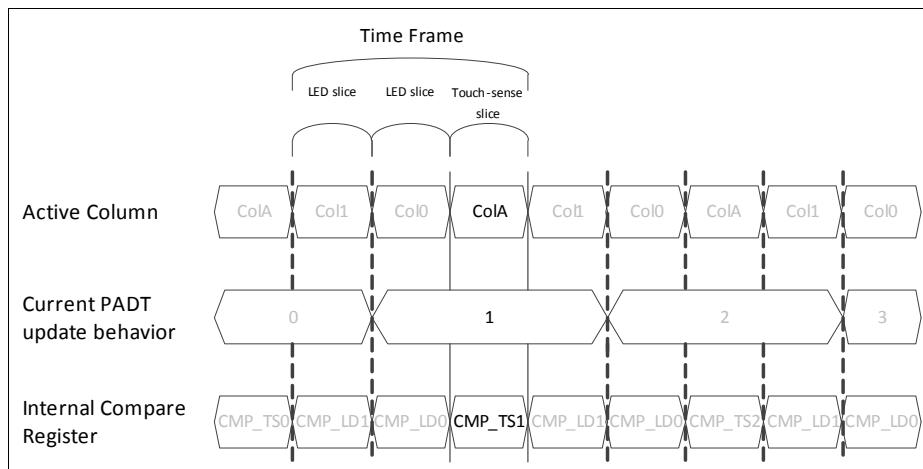
Figure 6 Internal Compare Register updated with correct compare register value with 2 LED columns enabled

If the number of LED columns enabled is 2 or more, the additional LED columns would provide some buffer time for the delay. So, at the start of a new touch-sense time slice, the update of PADT value would have taken place. Hence, the current active PADT compare register value is updated to the internal compare register ([Figure 6](#)).

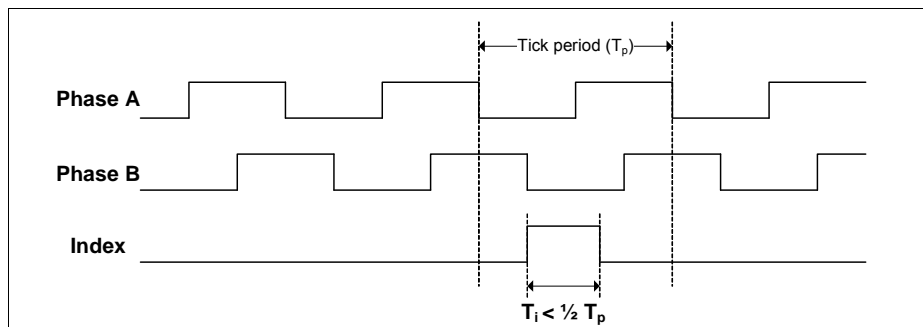
Figure 9 Different index signal types

When the index signal is smaller than 1/2 of the tick period, the POSIF module is not able to decode this signal properly, Figure 2 - notice that the reference edge of the index generation in this figure is the falling of Phase B, nevertheless this is an example and depending on the encoder type, this edge may be one of the other three.

Due to this fact it is not possible to use the POSIF to decode these type of signals (index with duration below 1/2 of the tick period).

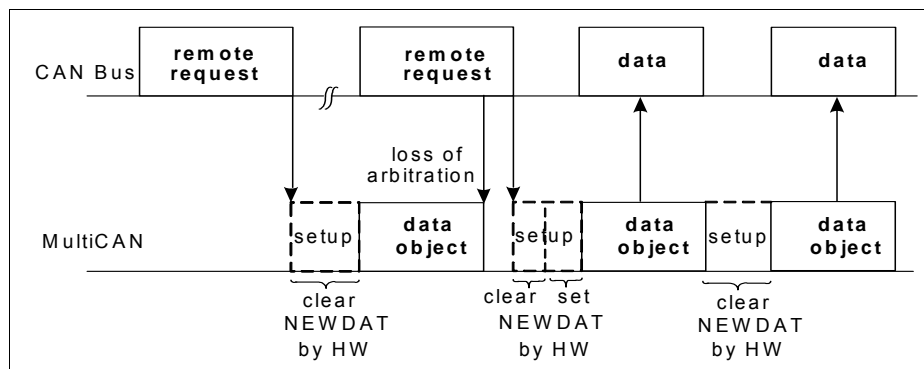
Figure 12 Loss of Arbitration

When the appropriate message object (data frame) triggered by the first remote frame wins the arbitration, it will be sent out and NEWDAT is not reset. This leads to an additional data frame, that will be sent by this message object (clearing NEWDAT).

There will, however, not be more data frames than there are corresponding remote requests.
