Device	XMC4700/XMC4800
Marking/Step	ES-AA, AA
Package	PG-LQFP-100/144, PG-LFBGA-196

Document ID is **03508AERRA**.

This “Errata Sheet” describes product deviations with respect to the user documentation listed below.

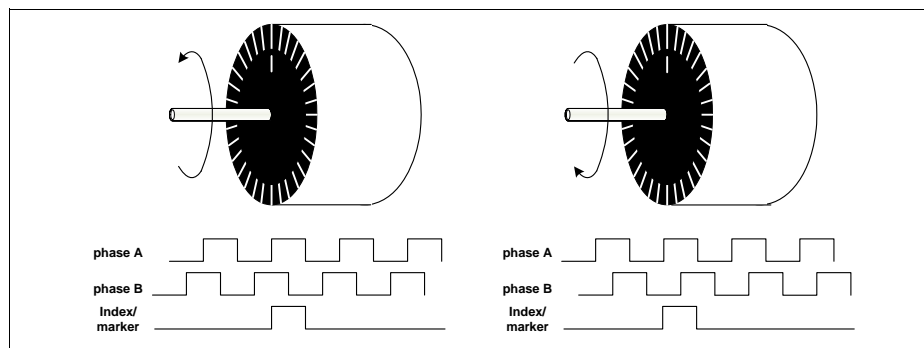
Figure 8 Rotary Encoder outputs - Phase A, Phase B and Index

POSIF AI.001 Input Index signal from Rotary Encoder is not decoded when the length is 1/4 of the tick period

Each POSIF module can be used as an input interface for a Rotary Encoder. It is possible to configure the POSIF module to decode 3 different signals: Phase A, Phase B (these two signals are 90° out of phase) and Index. The index signal is normally understood as the marker for the zero position of the motor Figure 1.
